## Success Stories

### Partial discharge detected on dry-type production transformer

### Hexpol Rubber Compounding – Critical failure detected.

## N1 Danish DSO – Early fault detection, recommending electrical testing.

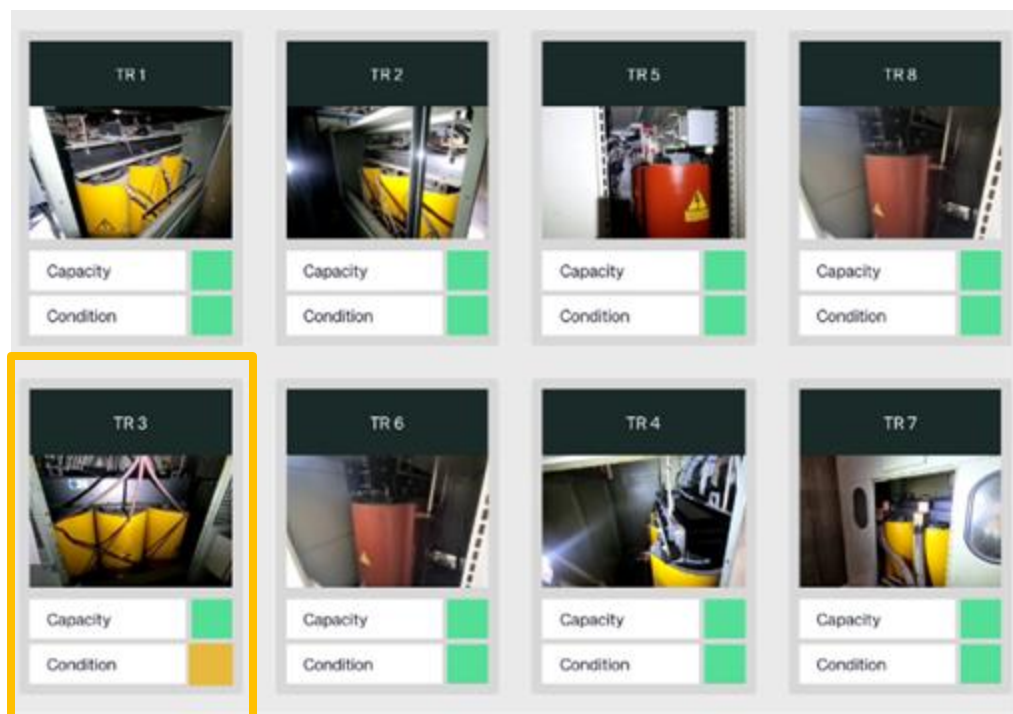
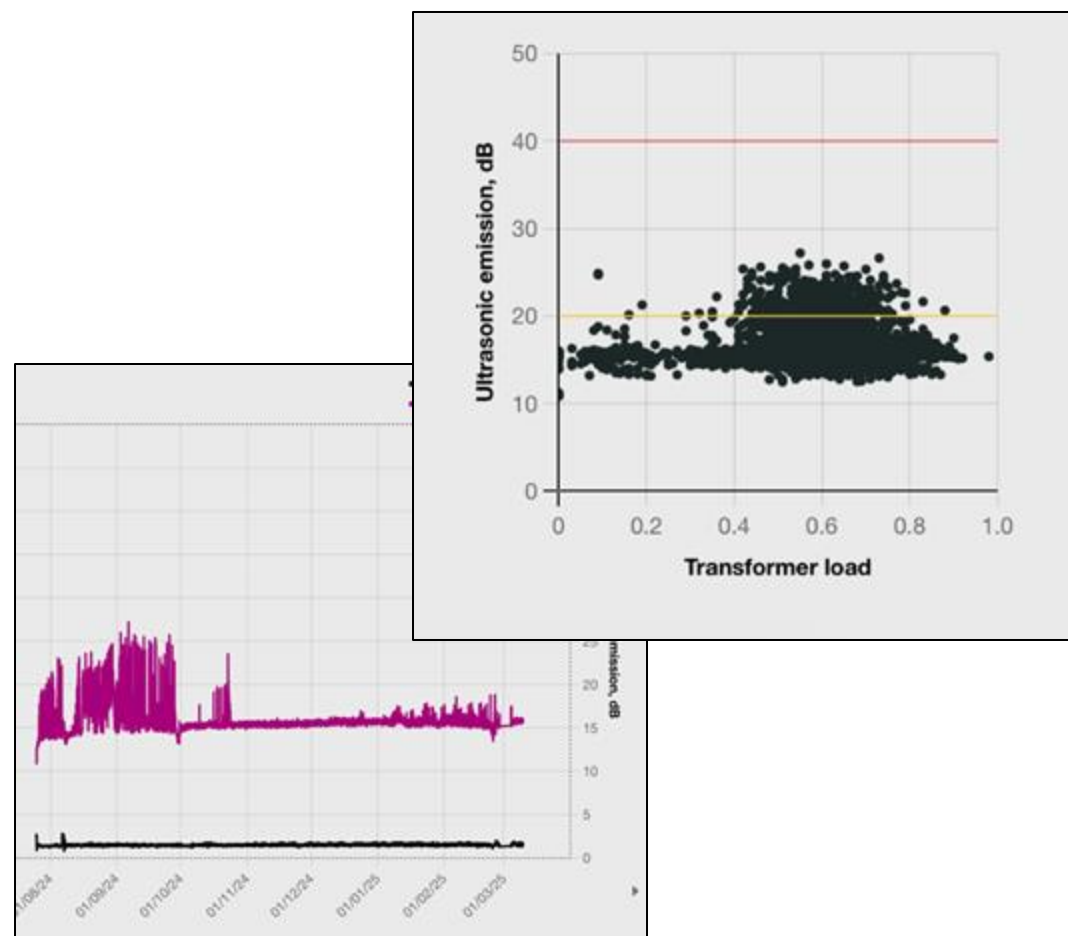
Bandag – Early fault detection, partial discharge detected.

- Mechanical state deteriorated significantly over 6 weeks
- Notification triggered
- ABB Belgium made maintenance call with customer

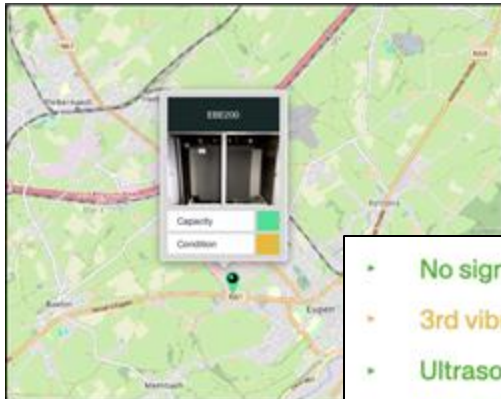
#### Critical transformer for securing production

- Electromechanical analysis shows possible winding deformation build-up
- Notification triggered
- SFRA test recommended

- No significant noises in electrical harmonics
- 3rd vibration harmonics close to threshold
- Ultrasonic emission levels do not indicate PD
- Sound Level in upper normal
- Temperatures normal

- **Core or Magnetic Circuit Disturbance:** A high third harmonic is often a sign of anomalies in the magnetic circuit, such as a core joint looseness or problems with the clamping structure. These can cause variations in the magnetic flux distribution and increase harmonic vibration.
- **Winding or Structural Resonance:** This could point to a structural resonance at the third harmonic frequency or mechanical looseness within the transformer. Resonance can amplify specific frequencies disproportionately.

- If the windings have undergone physical deformation (e.g., buckling, ovality, or displacement), their mechanical properties might change, causing them to resonate at specific harmonic frequencies. This resonance could amplify the vibration at the 3rd harmonic.
- Such deformations can arise due to:
  - Short-circuit forces in past events.
  - Manufacturing defects or improper clamping of windings.
  - Thermal expansion over time leading to loosened winding supports.

- In this scenario, conducting **dissolved gas analysis (DGA)** is recommended.
- **Offline electrical test** (like SFRA – Sweep Frequency Response Analysis) can help determine if there is physical deformation of the windings or core

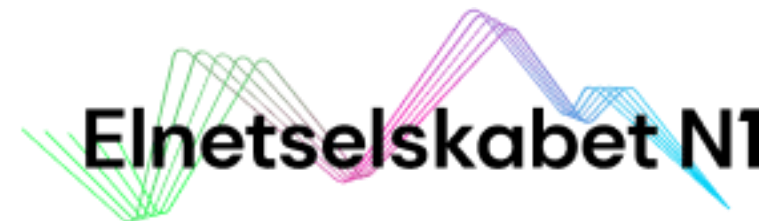
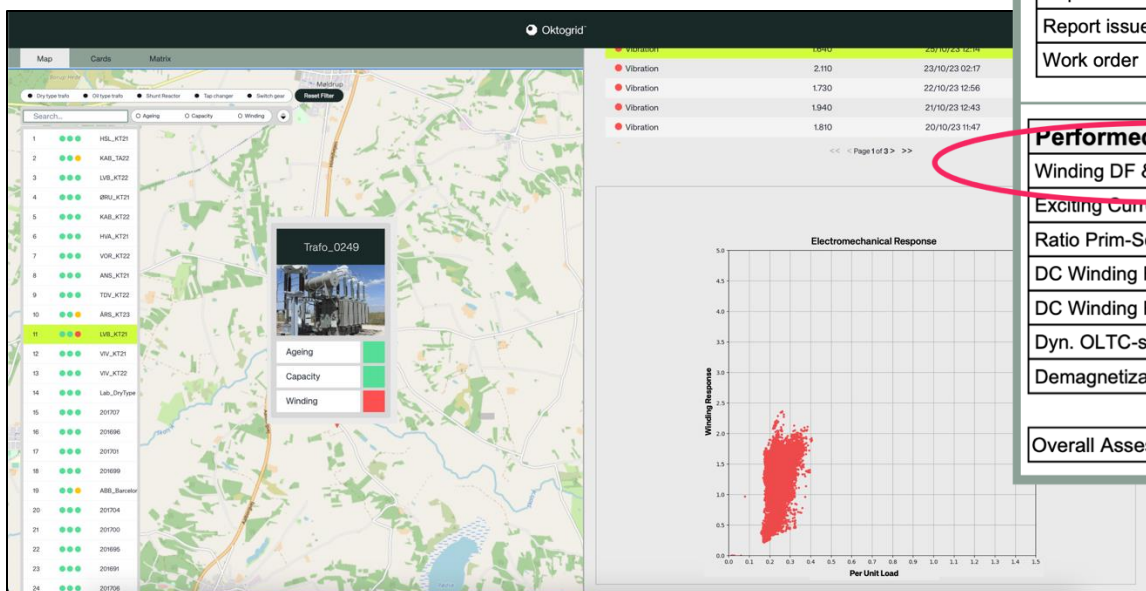
- Mechanical state deteriorated significantly over 6 weeks
- Notification triggered
- External maintenance team carried out electrical testing

Performed tests	Assessment
Winding DF & CAP	Fail <span style="color: red;">✖</span>
Exciting Current	Manual investigate <span style="color: yellow;">⚠</span>
Ratio Prim-Sec	Pass <span style="color: green;">✔</span>
DC Winding Resistance Prim	Pass <span style="color: green;">✔</span>
DC Winding Resistance Sec	Pass <span style="color: green;">✔</span>
Dyn. OLTC-scan (DRM) Prim	Pass <span style="color: green;">✔</span>
Demagnetization	Manual pass <span style="color: green;">✔</span>

Overall Assessment	Continued safe operation critical
--------------------	-----------------------------------

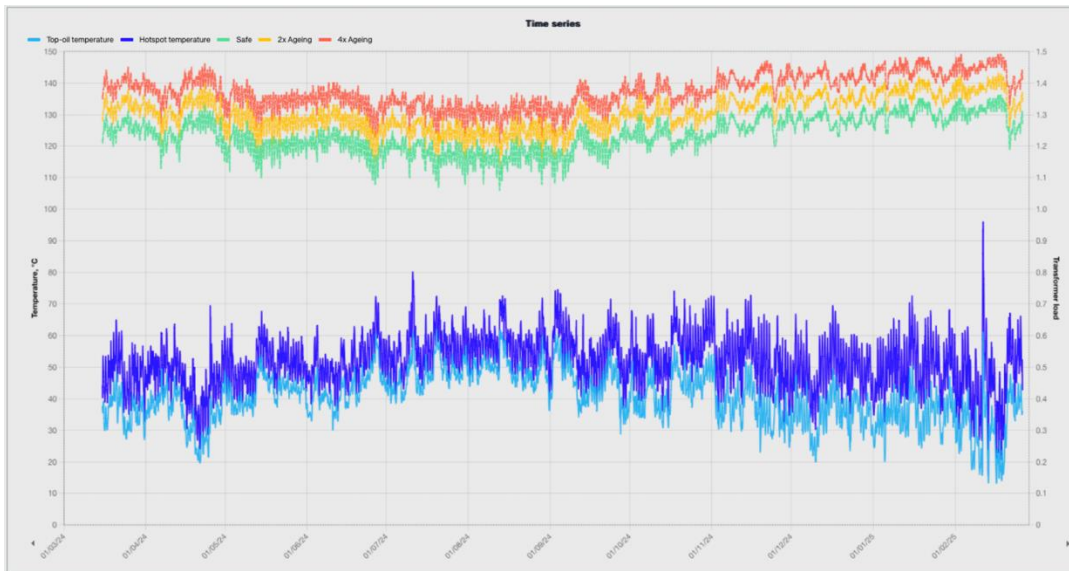
### Fleet of ageing transformers

- Thermal performance monitored across 20 transformers
- Analytics marked three transformers unfit for high loads
- Inspection of cooling system recommended for two transformer
